#### PRELIMINARY ASSESSMENT/ VISUAL SITE INSPECTION

BELL SPORTS, INC. (FORMER VETTER FAIRINGS COMPANY) RANTOUL, ILLINOIS ILD 075 611 525

#### FINAL REPORT

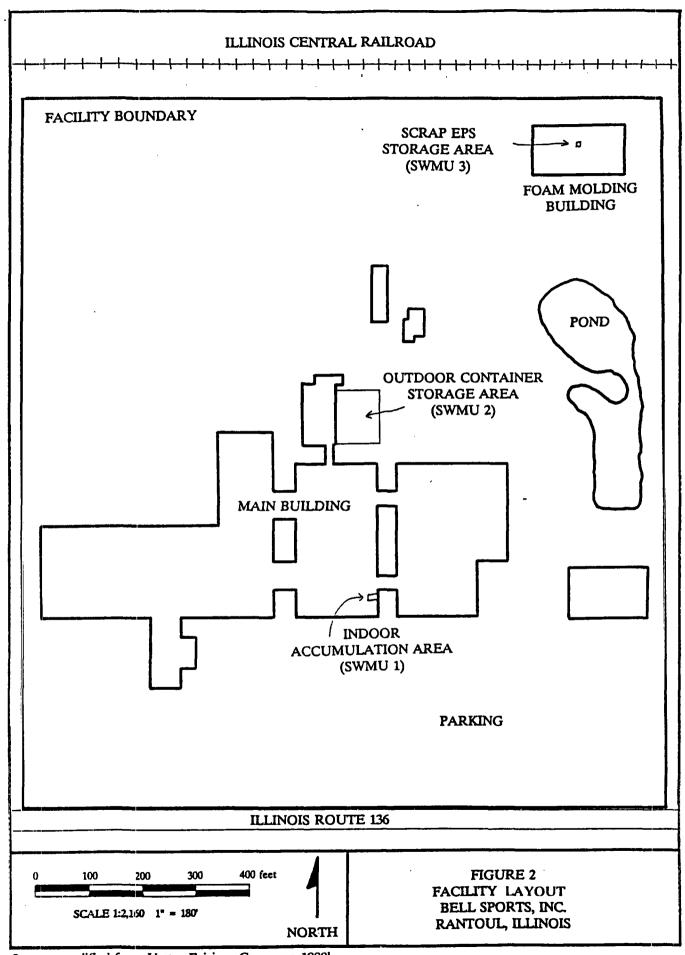
Wastes are generated and managed at various locations at the facility. SWMUs and their current status are identified in Table 1. The locations of the SWMUs in relation to the facility layout are shown in Figure 2. Wastes generated at the facility are summarized in Table 2. Facility generation and management of both hazardous and nonhazardous wastes are discussed below.

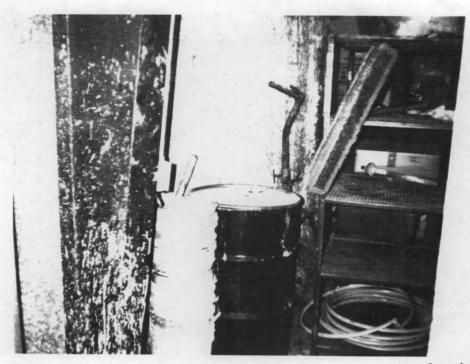
Observations: Dynamac observed one 55-gallon drum approximately one-third

full of paint waste with solvents (F003, F005) (See Photo No. 1). At the time of the VSI, the facility was not accumulating nonhazardous waste oil. The concrete floor in the area of this unit appeared to be in sound condition; there were no stains or

Photo No.: Orientation: Description: South Date: June 9, 1992
Indoor Accumulation Area centrally located in the southern half of the main building at the facility. The blue drum contains about 20 gallons of waste paint with solvents (F003, F005).

Recommendations: Dynamac recommends no further action for this unit.

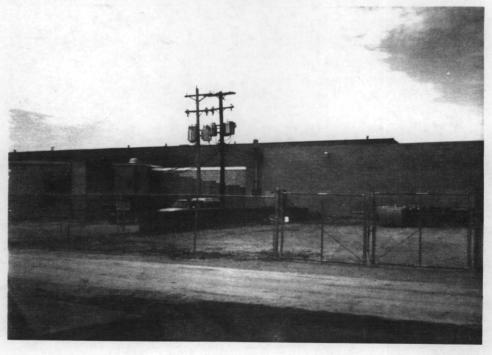
Photo No.: Orientation: Description: 2 West

Location: SWMU 2
Date: June 9, 1992

Southern-half of the Outdoor Container Storage Area centrally located within the facility. The 55-gallon drums along the south side of this unit are empty raw material drums awaiting return to the manufacturer.

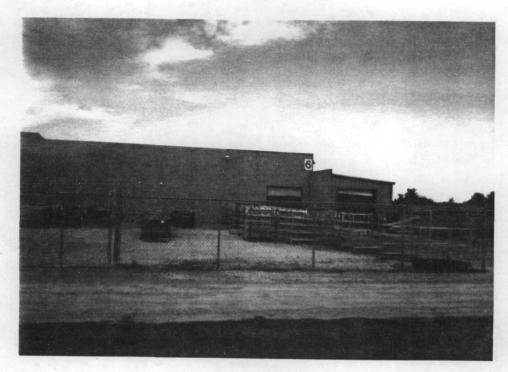
Photo No.: Orientation: Description: 3 West

Dynamac observed twelve 55-gallon drums containing waste paint with solvent (F003, F005), each of which were stored on wood pallets and were labeled and dated (See Photo Nos. 3 and 4). Two of these drums were dated March 1, 1992, which indicates the facility stored the drums for greater than 90 days. However, Nick Riddle of Bell stated the facility had mislabeled the two drums, and the date should have read April 1, 1992.

Northern-half of the Outdoor Container Storage Area.

Location: SWMU 2 Date: June 9, 1992

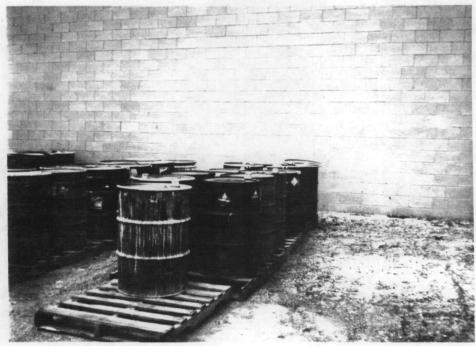
Photo No.: Orientation: Description:

Location: SWMU 2
Date: June 9, 1992

Close-up of twelve 55-gallon drums containing waste paint with solvents (F003, F005) located in the north half of the Outdoor Container Storage Area.

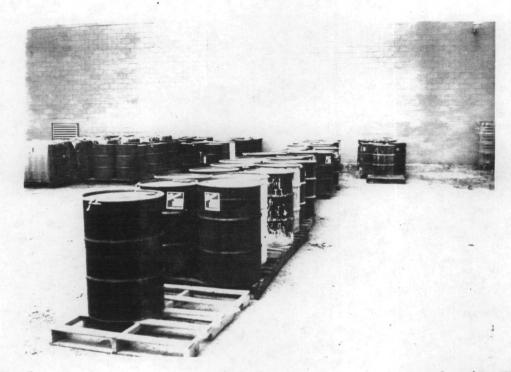
Photo No.: Orientation: Description: 5 West

Mr. Riddle stated Bell had not stored hazardous waste at the facility for greater than 90 days since the unit underwent IEPA-approved RCRA closure in 1988. Dynamac also observed numerous empty drums and forty-five 55-gallon drums of nonhazardous paint sludge on wood pallets within the unit (See Photo Nos. 2 and 5). There were no visible stains or evidence of a previous release in the area of this unit.

Location: SWMU 2 Date: June 9, 1992

Close-up of forty-five 55-gallon drums containing nonhazardous paint sludge located in the north half of the Outdoor Container Storage Area.

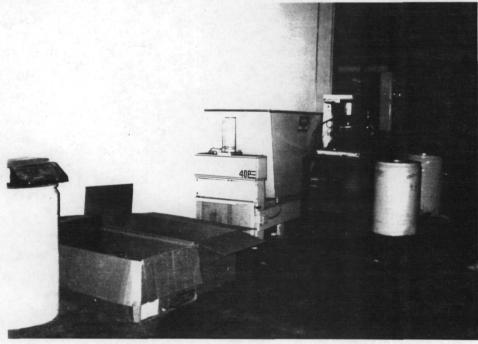
Dynamac observed one sealed six-cubic-foot cardboard box containing scrap EPS located on a wood pallet and one open six-cubic-foot cardboard box about half-full with scrap EPS in this unit (See Photo Nos. 6 and 7). There were no visible stains or evidence of a previous release in the area of this unit.

Photo No.: Orientation: Description: 6 Location: SWMU 3 East Date: June 9, 1992 An unsealed cardboard box half-full of nonhazardous scrap EPS located in the Scrap EPS

Storage Area.

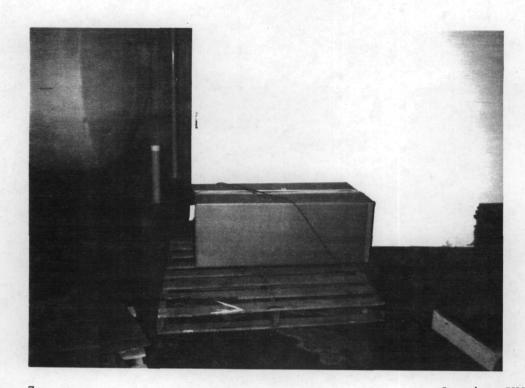
Photo No.: Orientation: Description:

Location: SWMU 3 North Date: June 9, 1992 A sealed cardboard box full of nonhazardous scrap EPS located in the Scrap EPS Storage Area.
